**GALVANIC ASPECTS OF ALUMINUM
SACRIFICIAL ANODE ALLOYS IN SEAWATER.**

THESIS

Galvanic Aspects of
Aluminum Sacrificial Anode Alloys
in Seawater

December 1977

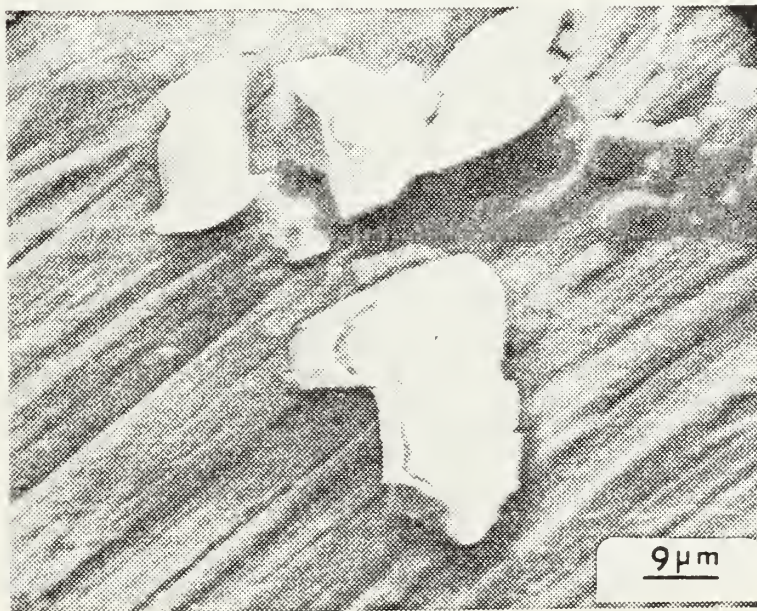
Figure 86

RII-96 (1100X) Corrosion product on surface of Reynode®II ninety-six-hour specimen which was analyzed with the X-ray spectrometer
